Re: July 2015 Monthly Progress Report
Administrative Settlement Agreement and Order on Consent for Removal Action
U.S. EPA Region 10 Docket No. CERCLA 10-2009-0255
Gasco Sediments Site within the Portland Harbor Superfund Site

Visual Observations Log Form

Monitoring Period: Monthly (Year 9) — July 2015

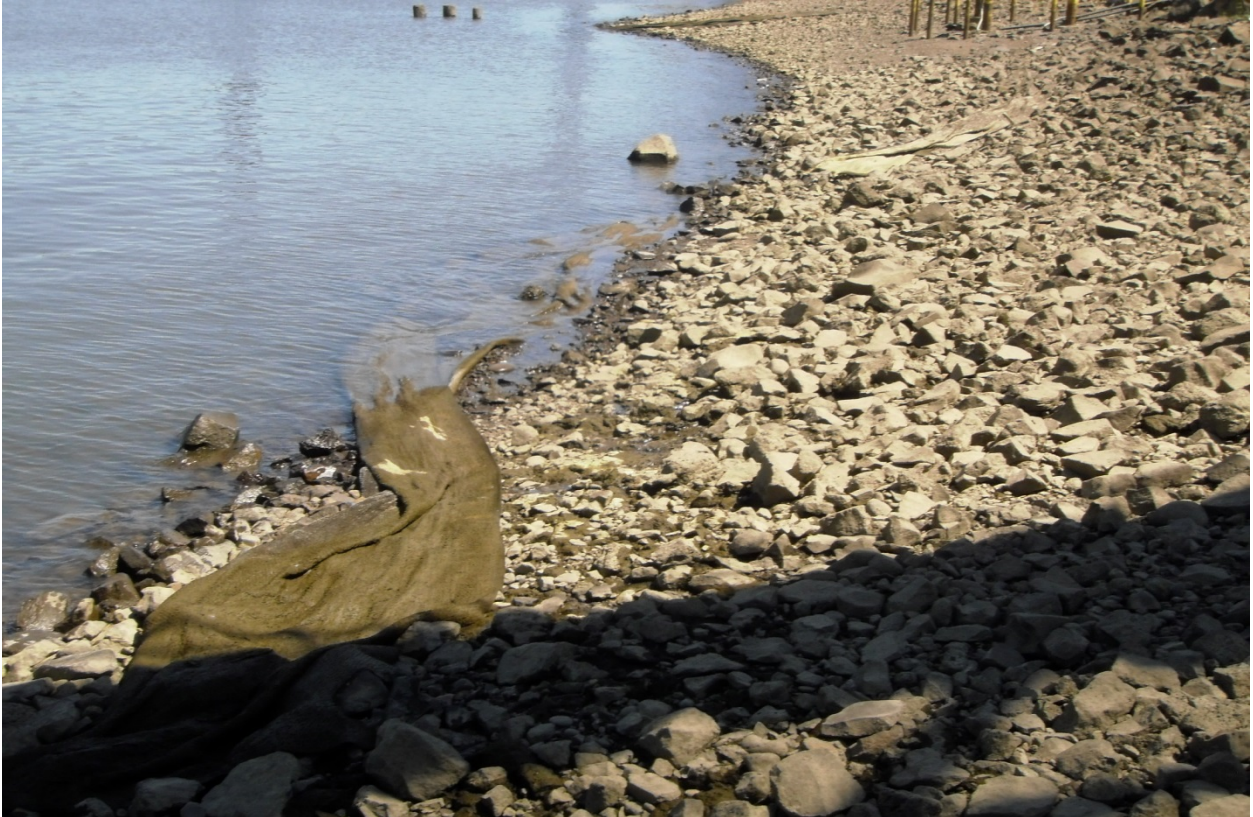
Observations of Erosion/Deposition: No erosion / deposition was observed along the shoreline. All previously noted organo-clay mat material segments are visible with many of the segments shoreward of the water's edge (see Photo 1).

Photo 1 — *Visible section of organo-clay mat along the shoreline at the downriver extent of the cap area (7/28/15):*

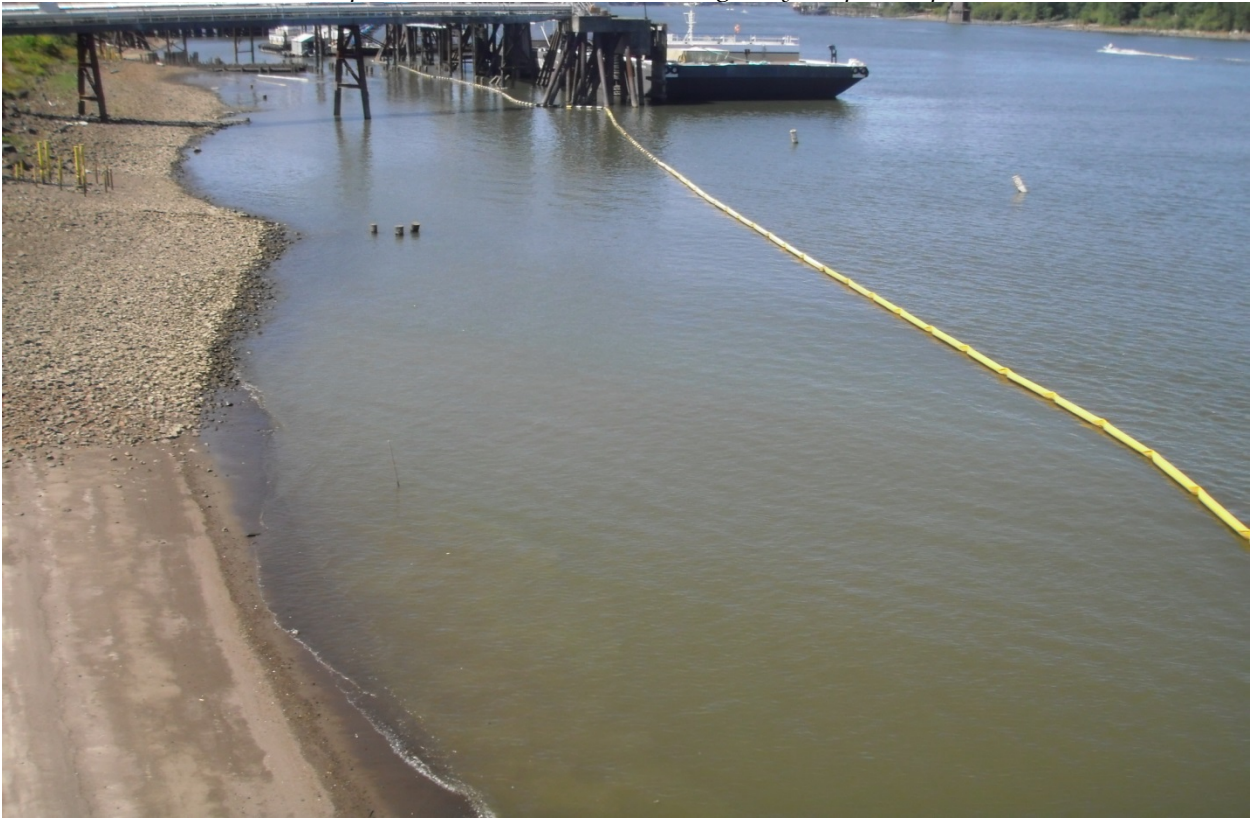
Observations of Long-term Controls (i.e., oil booms, organo-clay mat, etc.) During the observation, a barge was tied to the Fuel and Marine Marketing (FAMM) dock but the FAMM containment boom was in place, across the cap area, between the upriver corner of the ship dock and the wooden dolphin (near the upriver extent of the site and near the Siltronic Corporation outfall). Two buoys that identify the cap area to mariners are in place as installed. The position of the FAMM oil boom, warning buoys, and a general overview of the site shoreline is shown in Photo 2.

Photo 2 — *FAMM oil boom placement and mariner warning buoys at pilot cap area. (7/28/15):*

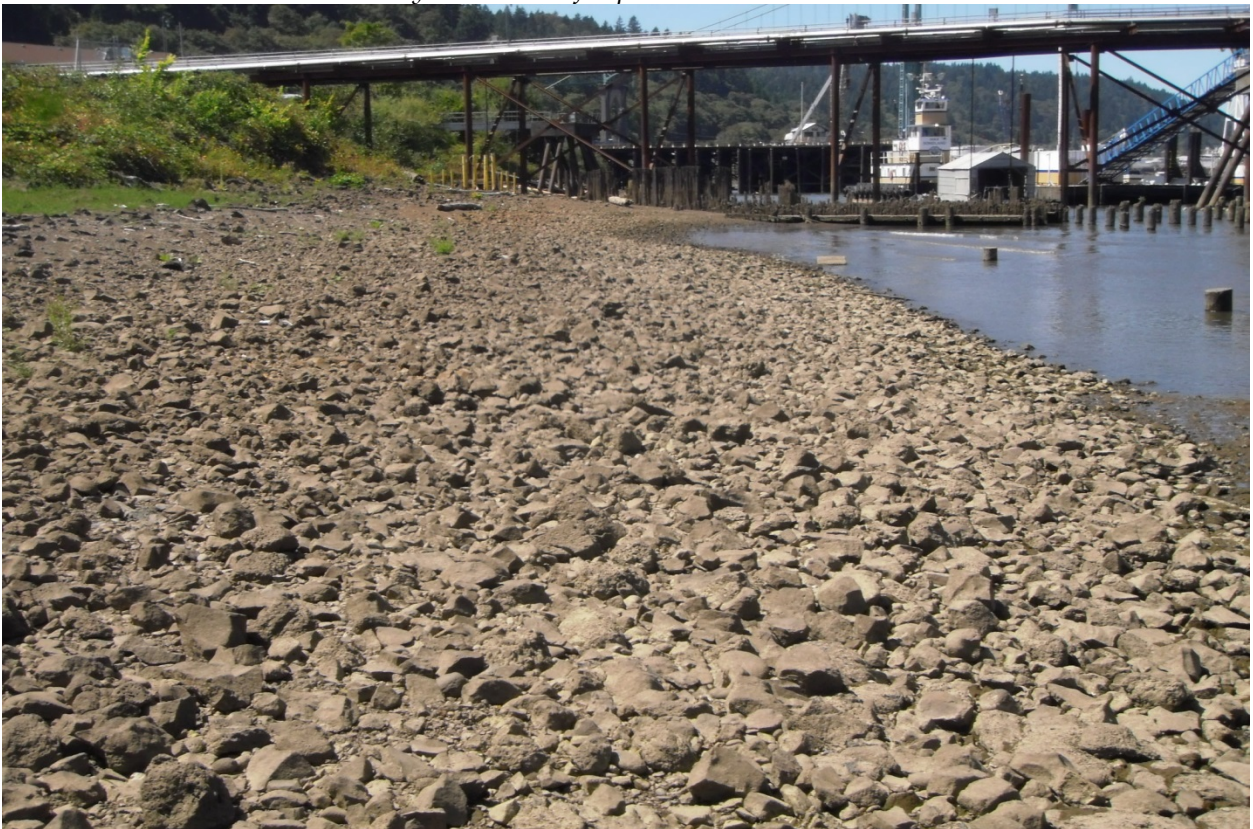
No sheen is evident in or around the cap area. Photo 3 shows the water surface and shoreline immediately downriver of the sediment cap.

Photo 3 — *Conditions immediately downriver of cap area (7/28/15):*
